# Unlocking the Drive

*Exploiting Tesla Model 3*

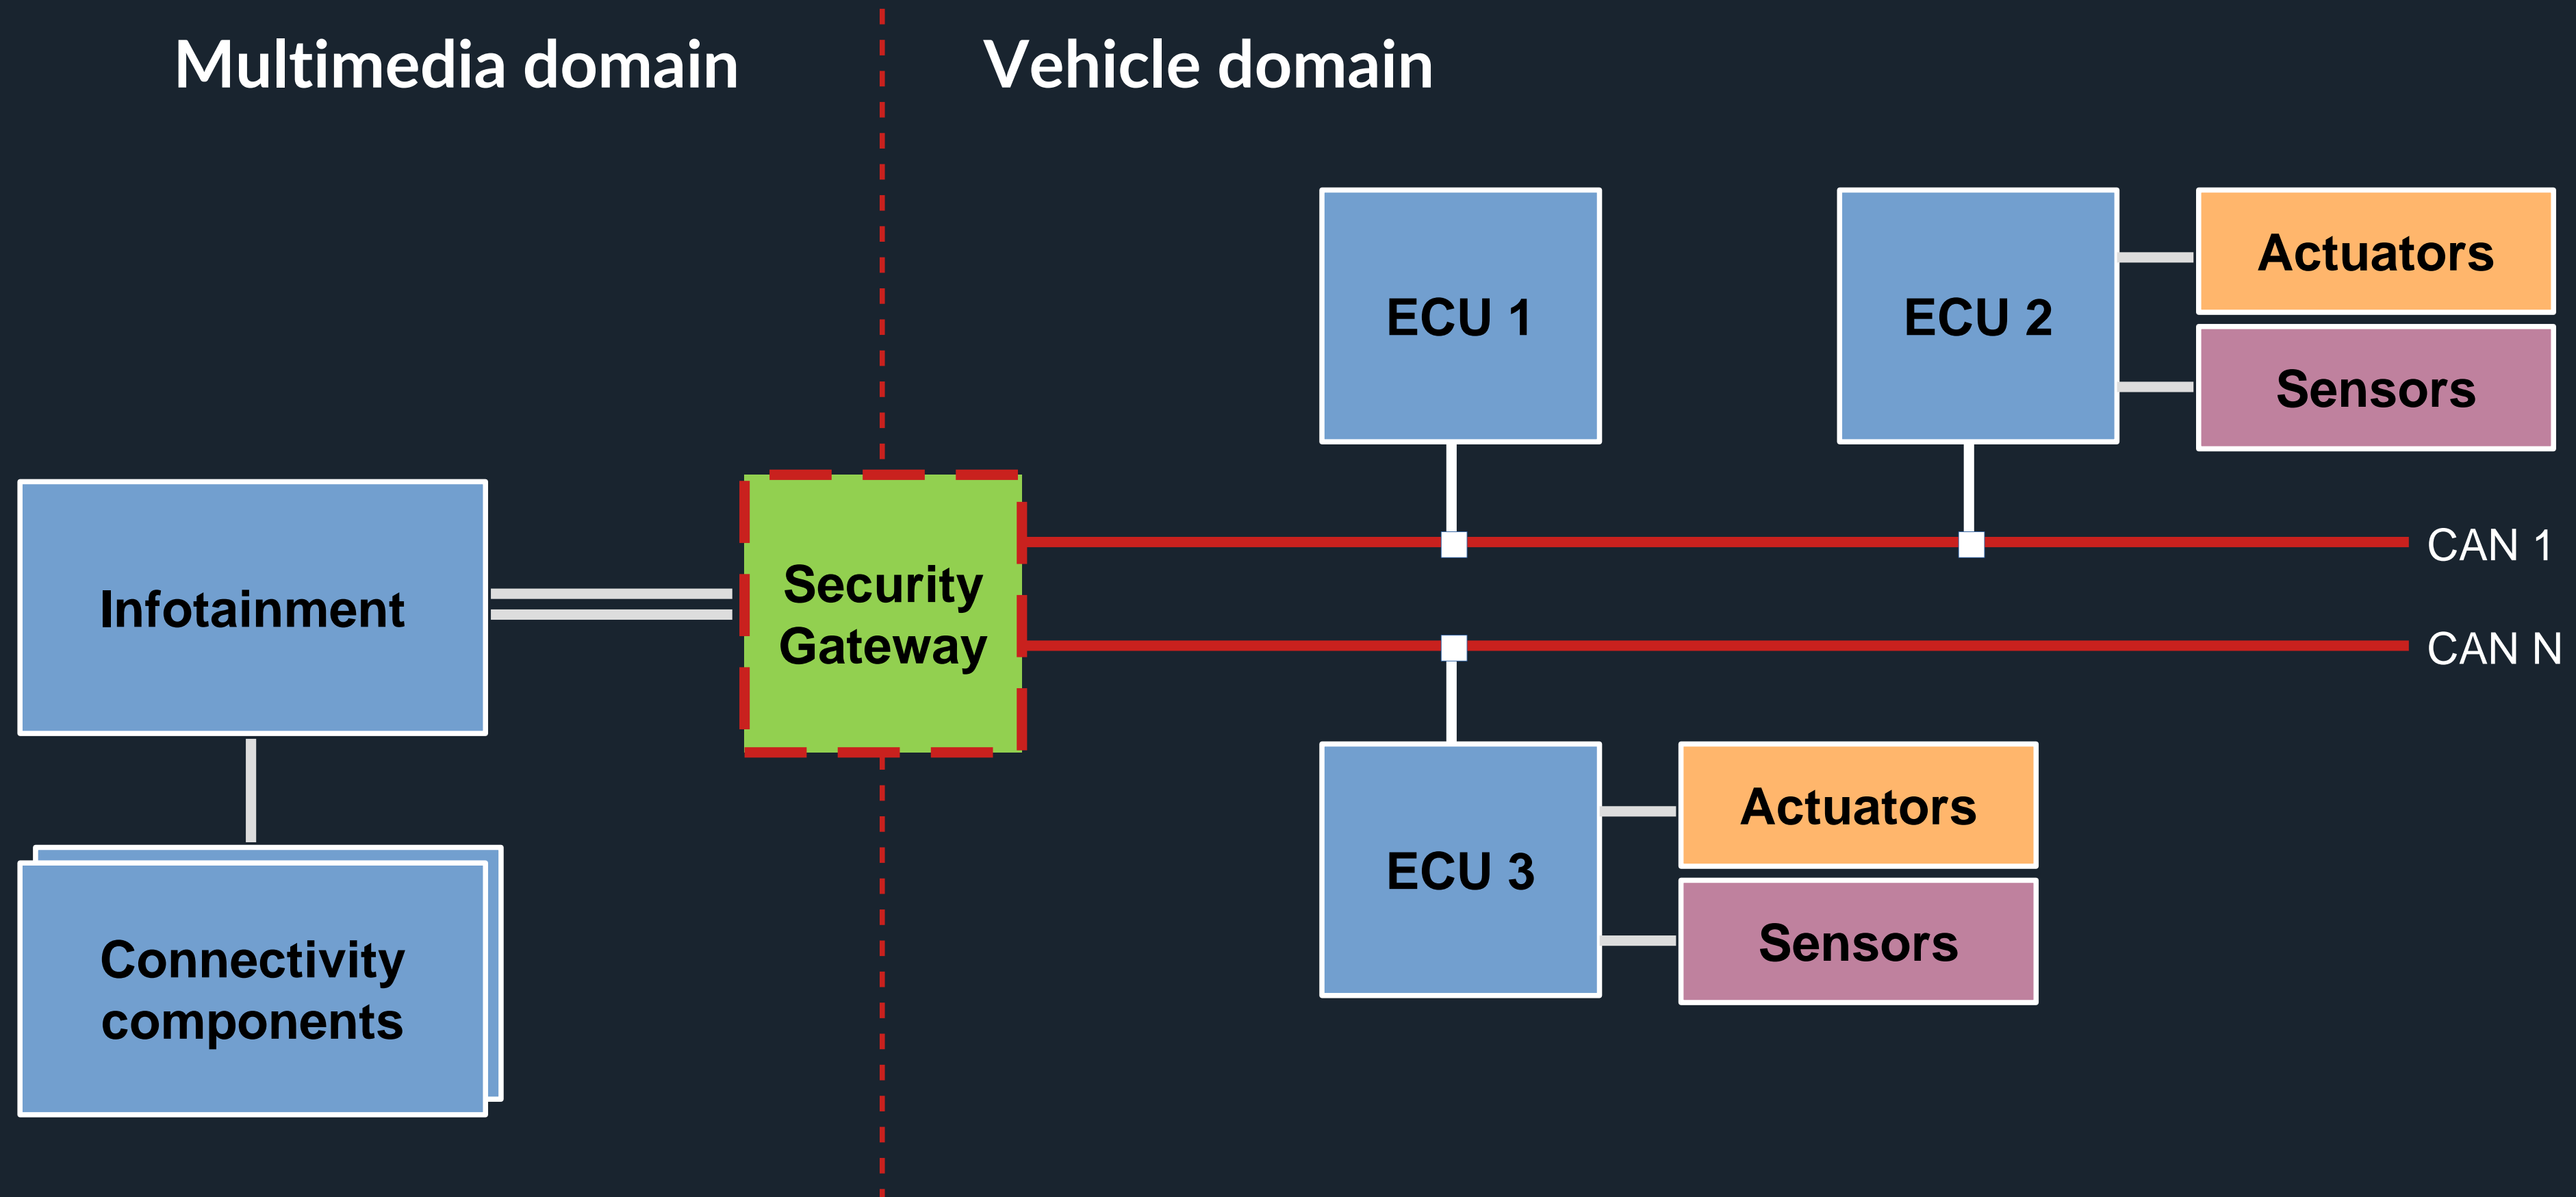
# Car architecture

Multimedia and vehicle domains separated by a gateway

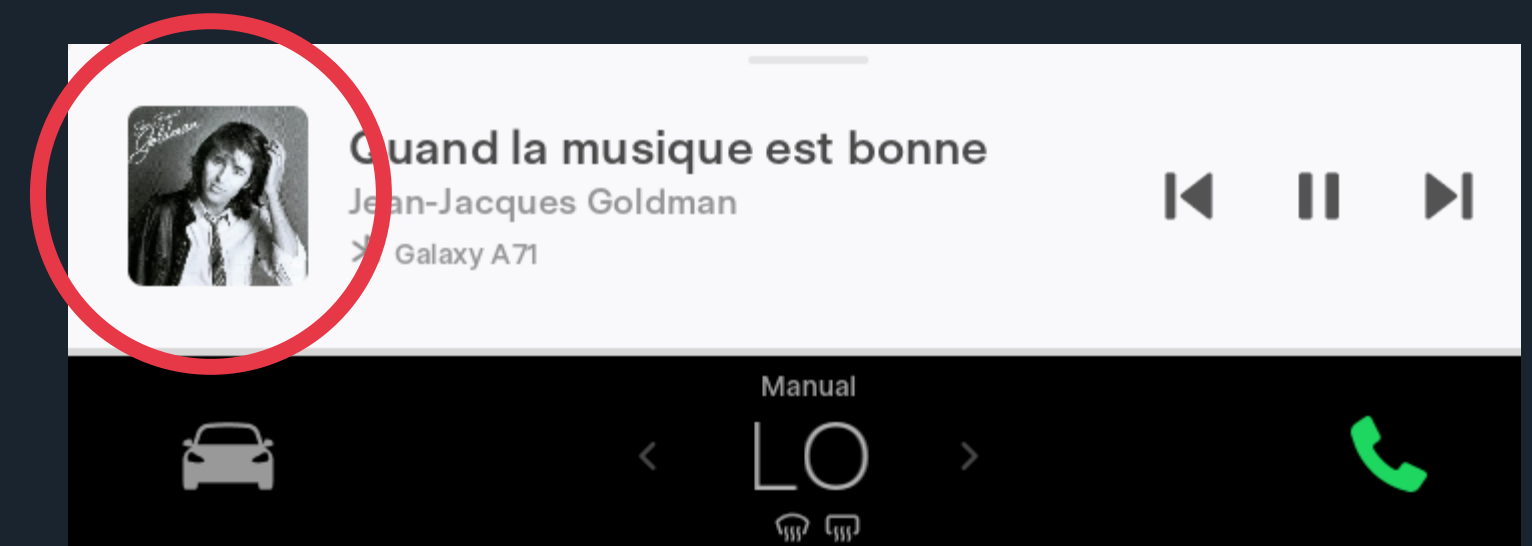
# BIP

1 Playback is configured by the phone (AVRC)

2 The car queries available Cover Art pictures using OBEX protocol

3 The phone send available images description using OBEX protocol

4 The car downloads and displays one image

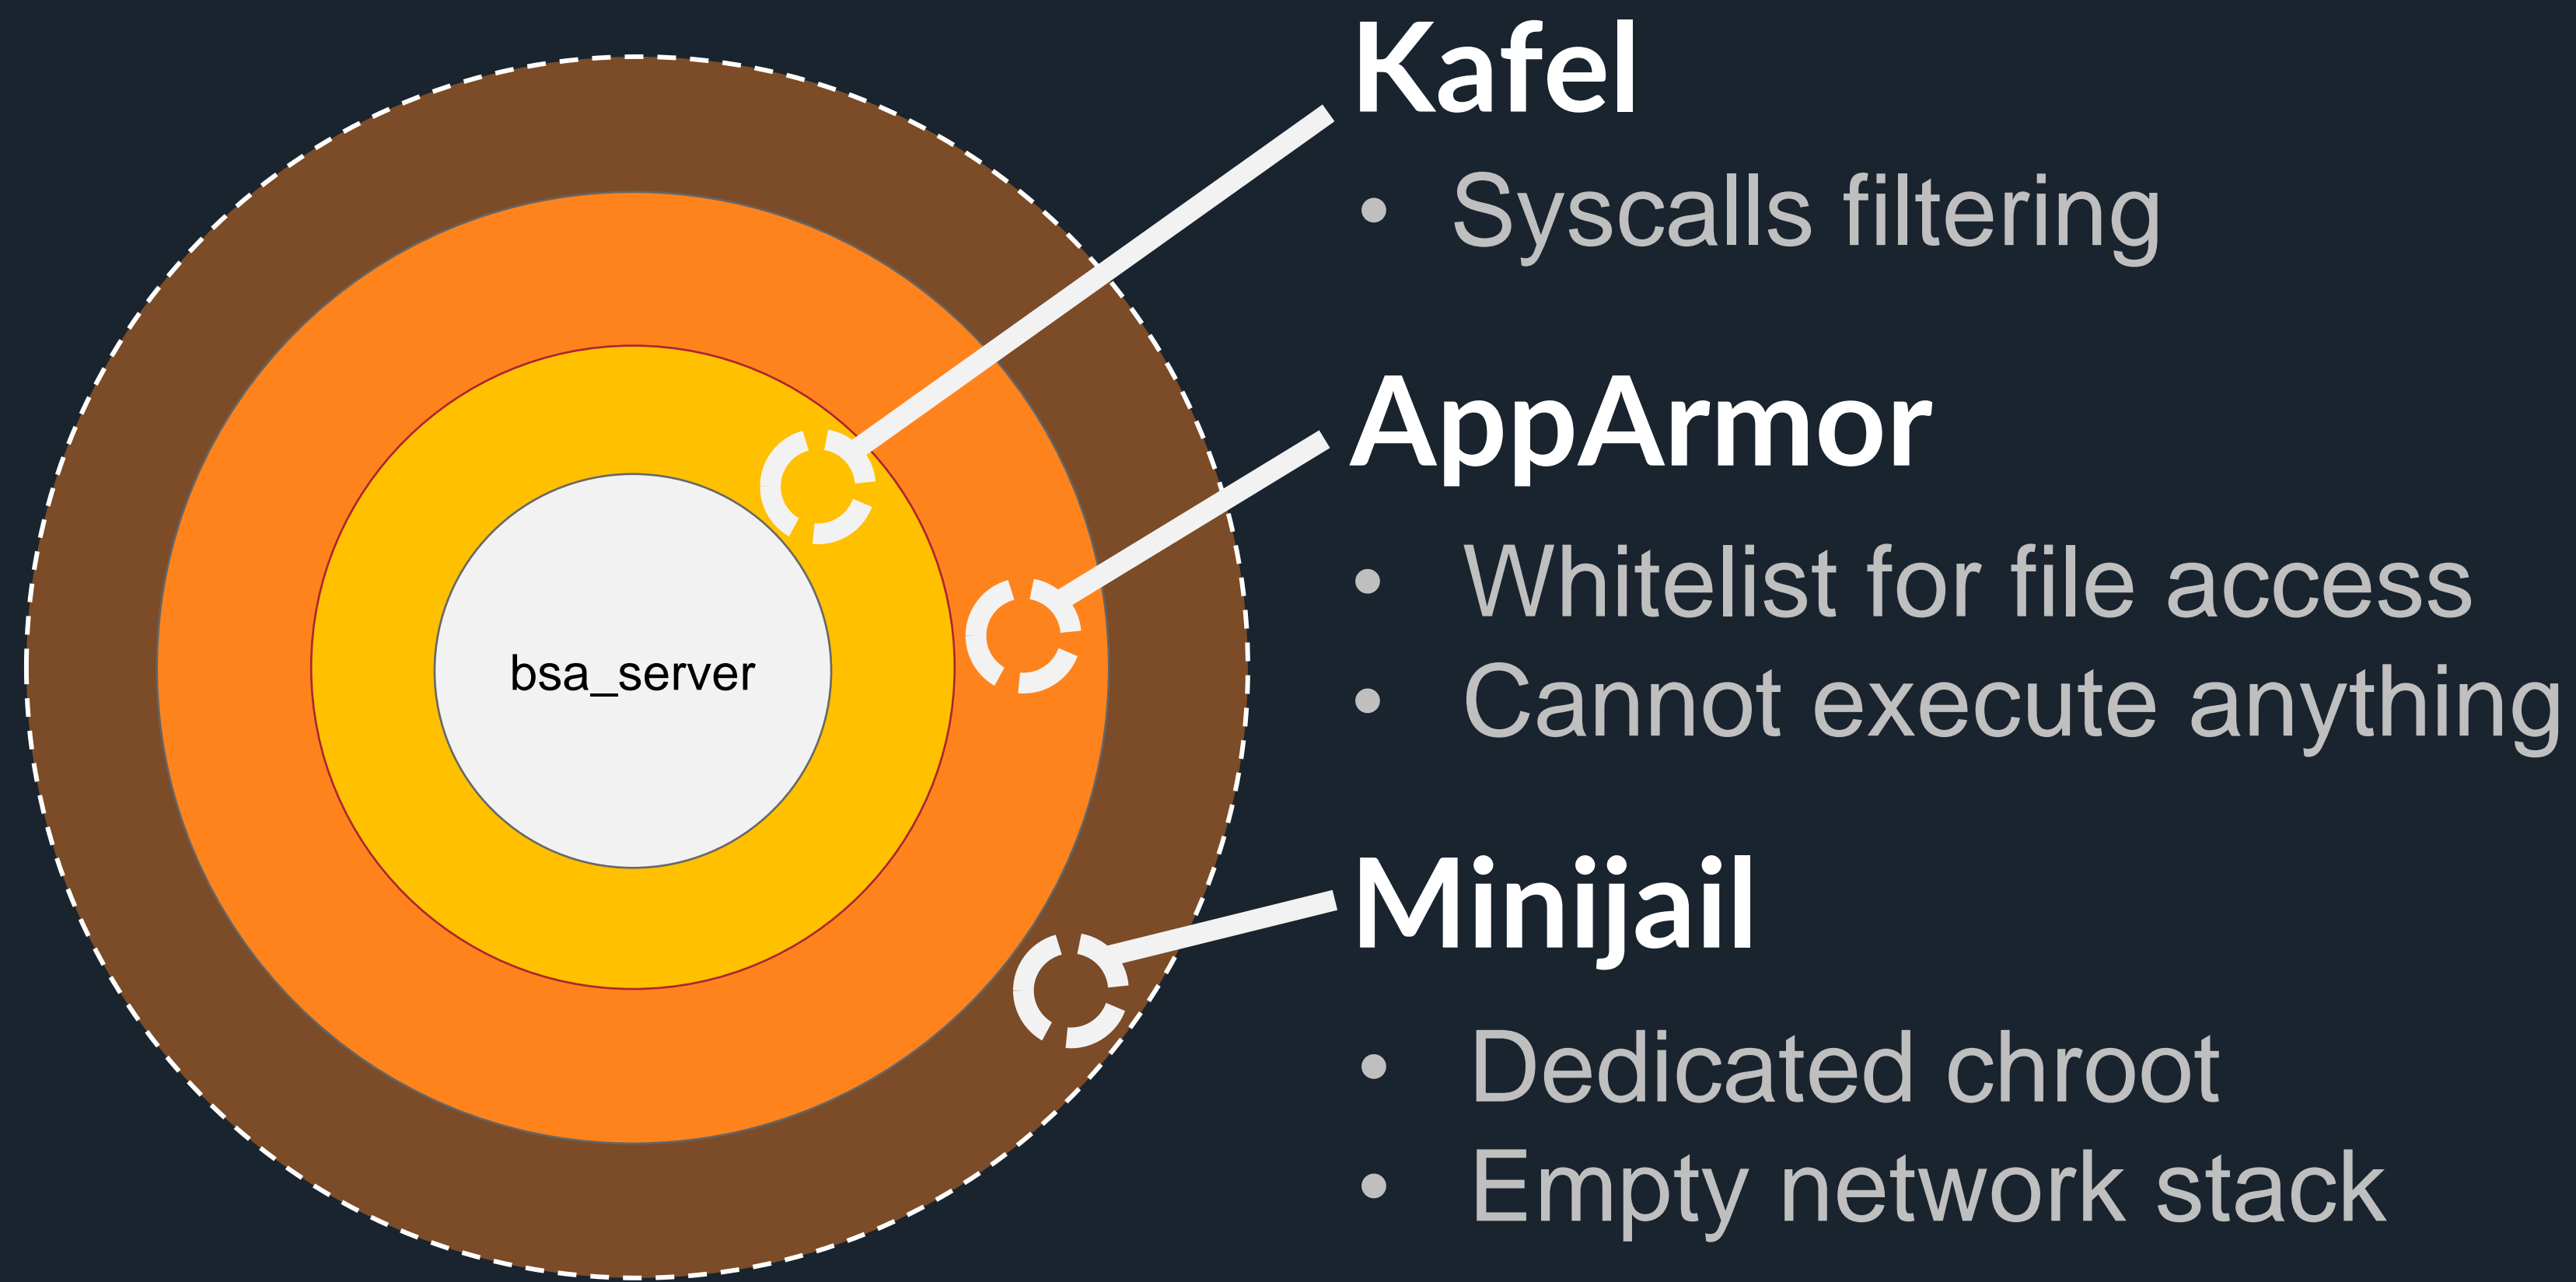
# The end ?

- Dedicated UID
- No useful capability
- No network
- All **sandboxes activated**
- But two legitimate APIs
  - TTY communication
  - One UNIX socket to communicate with btd
- Limited attack surface

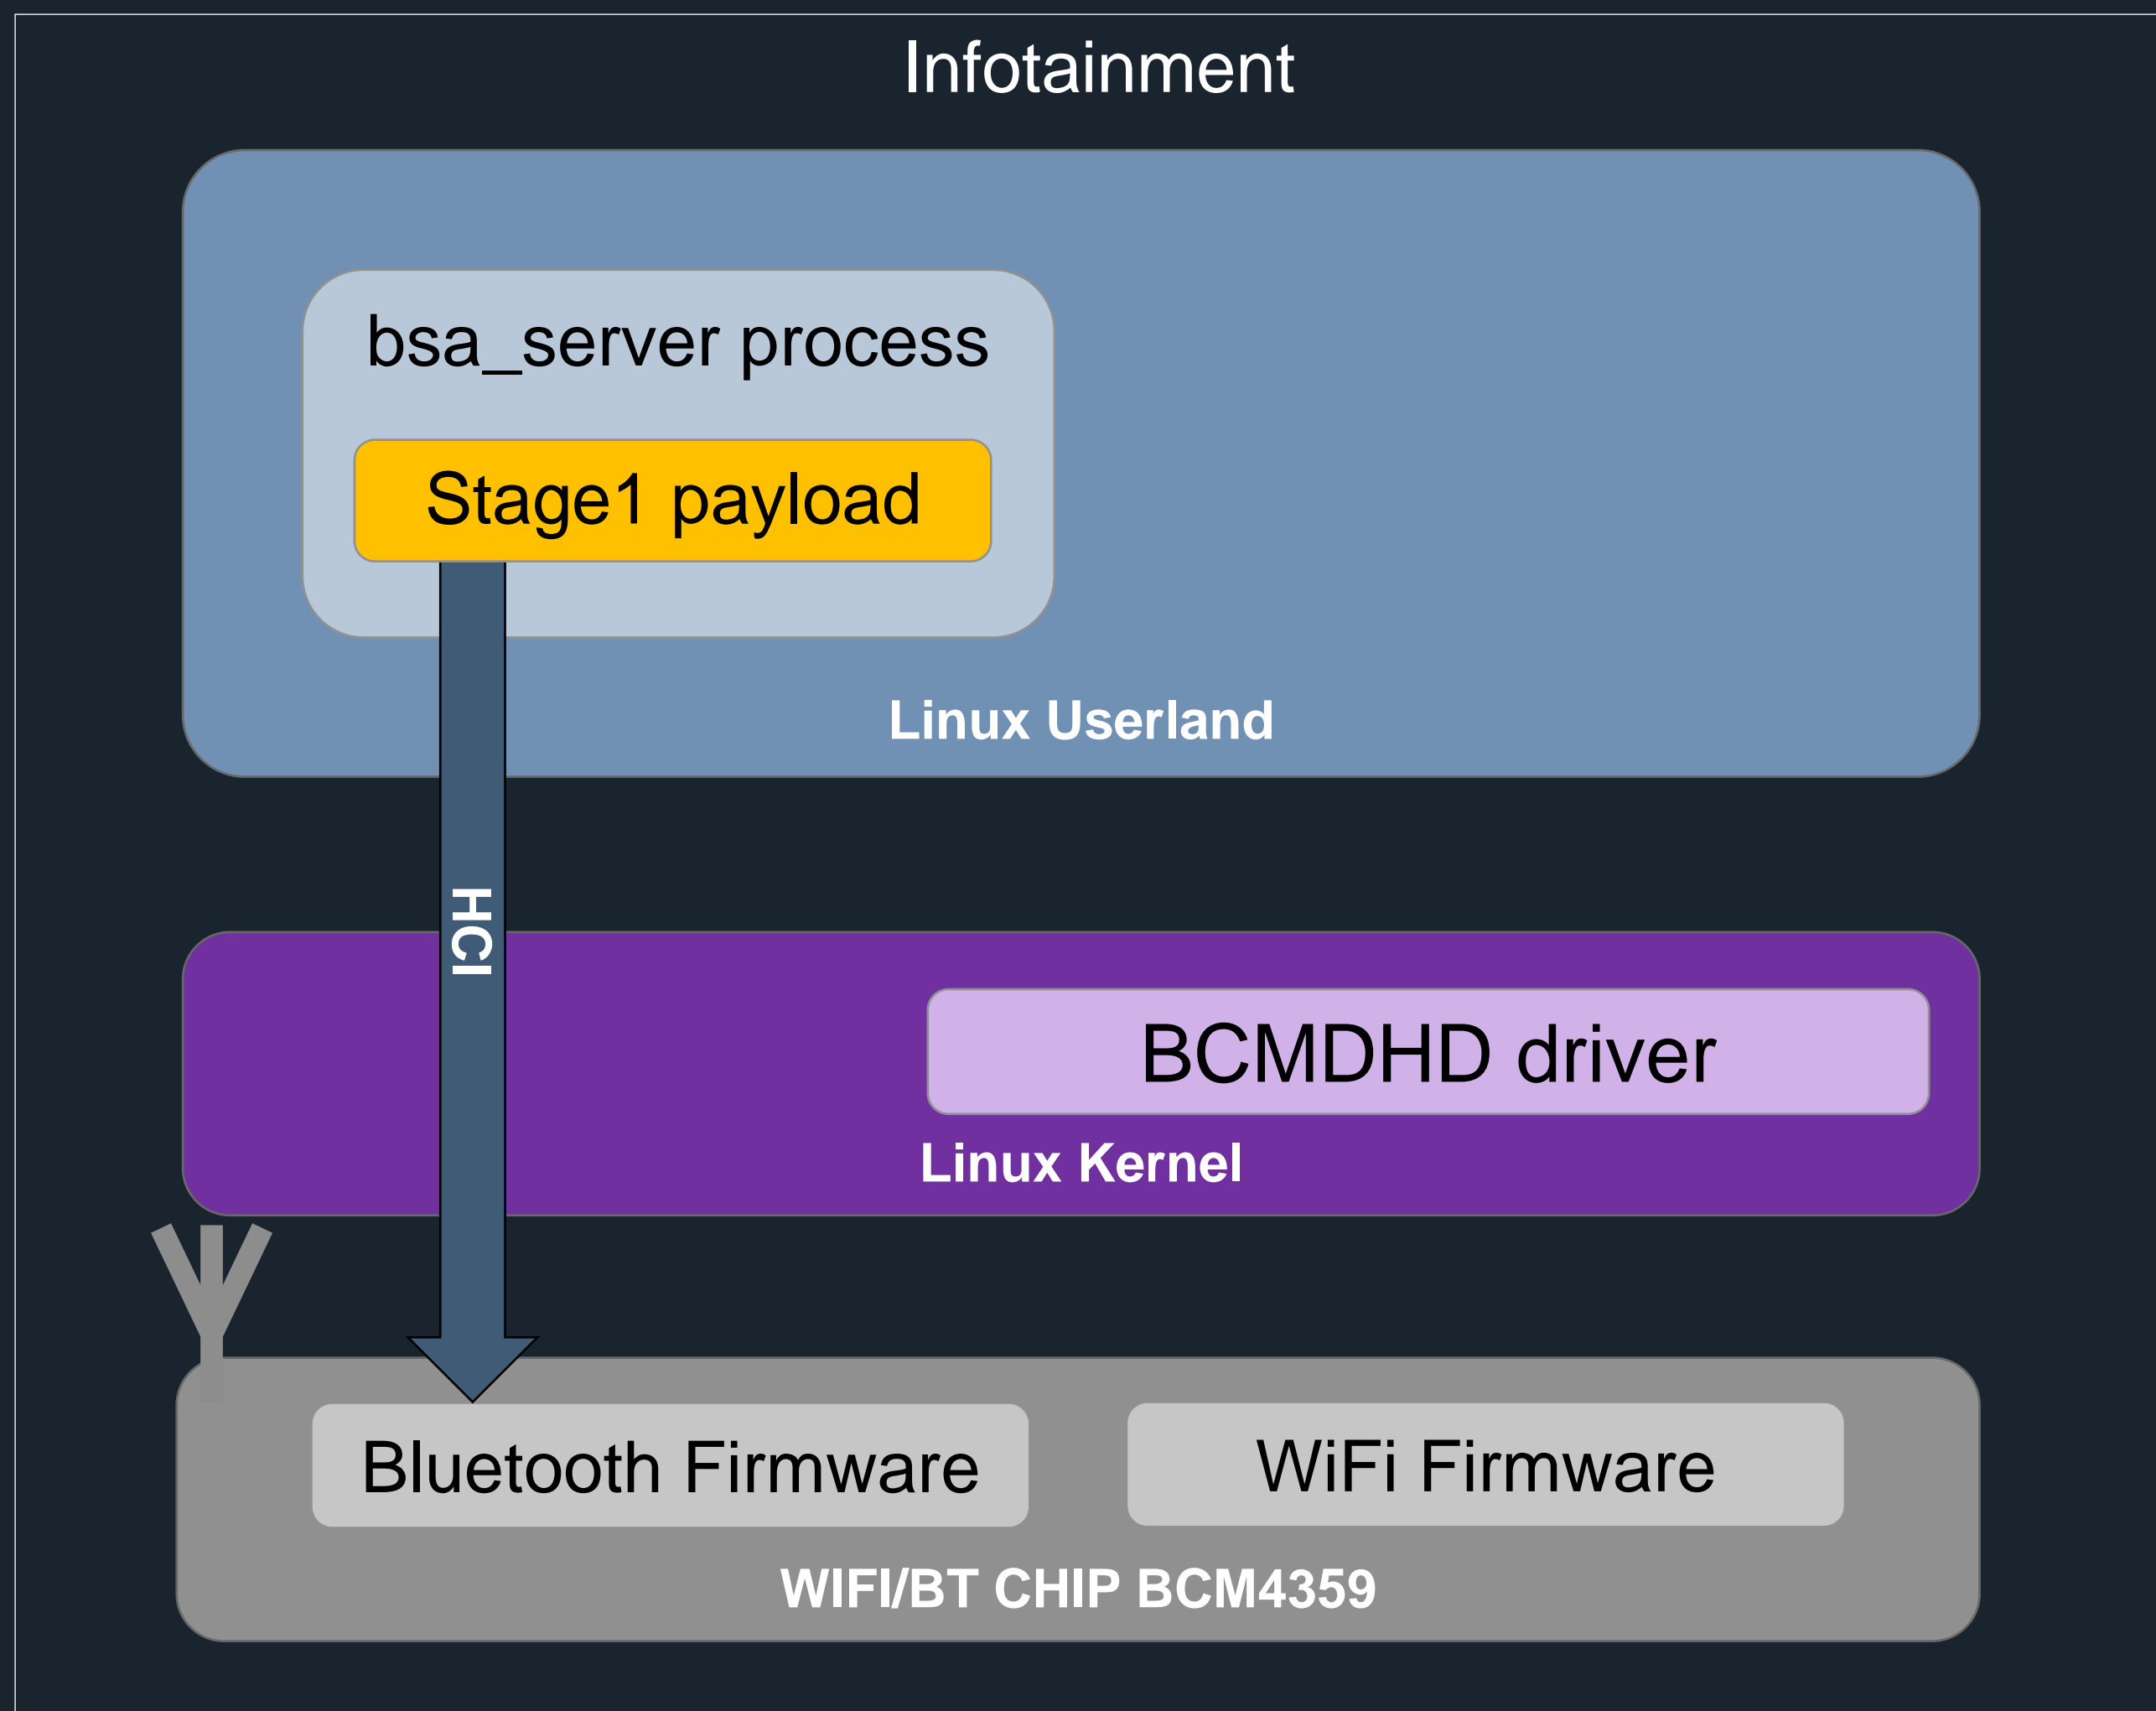
Arbitrary write inside the chipset firmware

- `bsa_server` communicates with Bluetooth chipset through HCI protocol
- Vendor specific commands are used to initialize the chipset (i.e. load Bluetooth firmware patches)
- At least `HCI_BRCM_WRITE_RAM` and `HCI_BRCM_SUPER_PEEK_POKE` commands allow arbitrary writing to the internal chipset memory
- So `stage1` injected in `bsa_server` can write inside the chipset memory

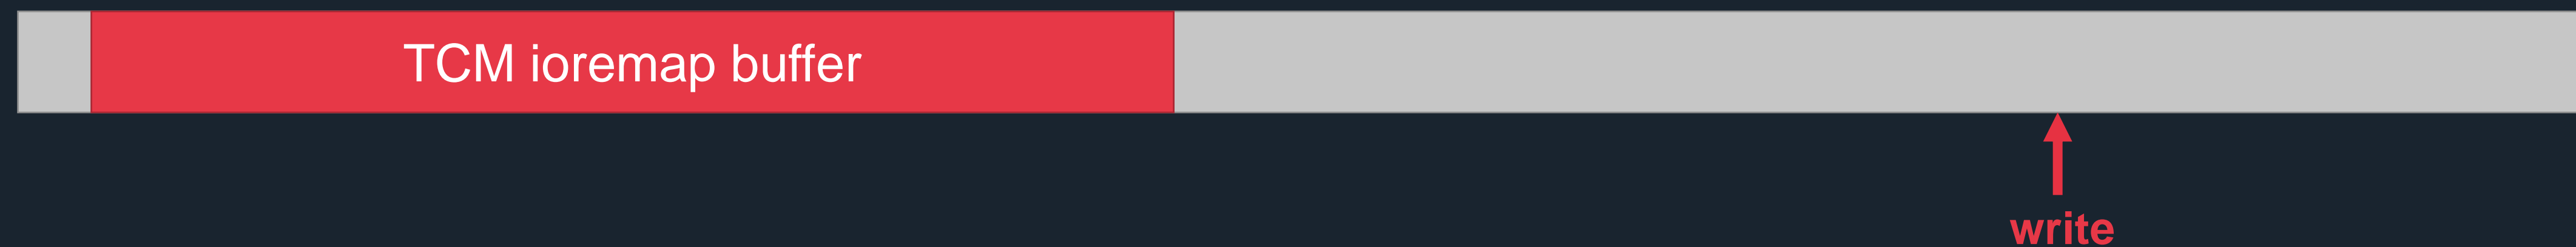
Out-of-bound write in bcmdhd

- `d2h_r_idx_ptr` is used as an offset to write inside a ioremap region (TCM)
- The offset is not checked to be in the TCM region!
- ioremap places addresses in the vmalloc region
- **Stage2** can write out of bound after the ioremap TCM region by setting `d2h_r_idx_ptr` to a value bigger than the TCM size
- Need to find something to write on!

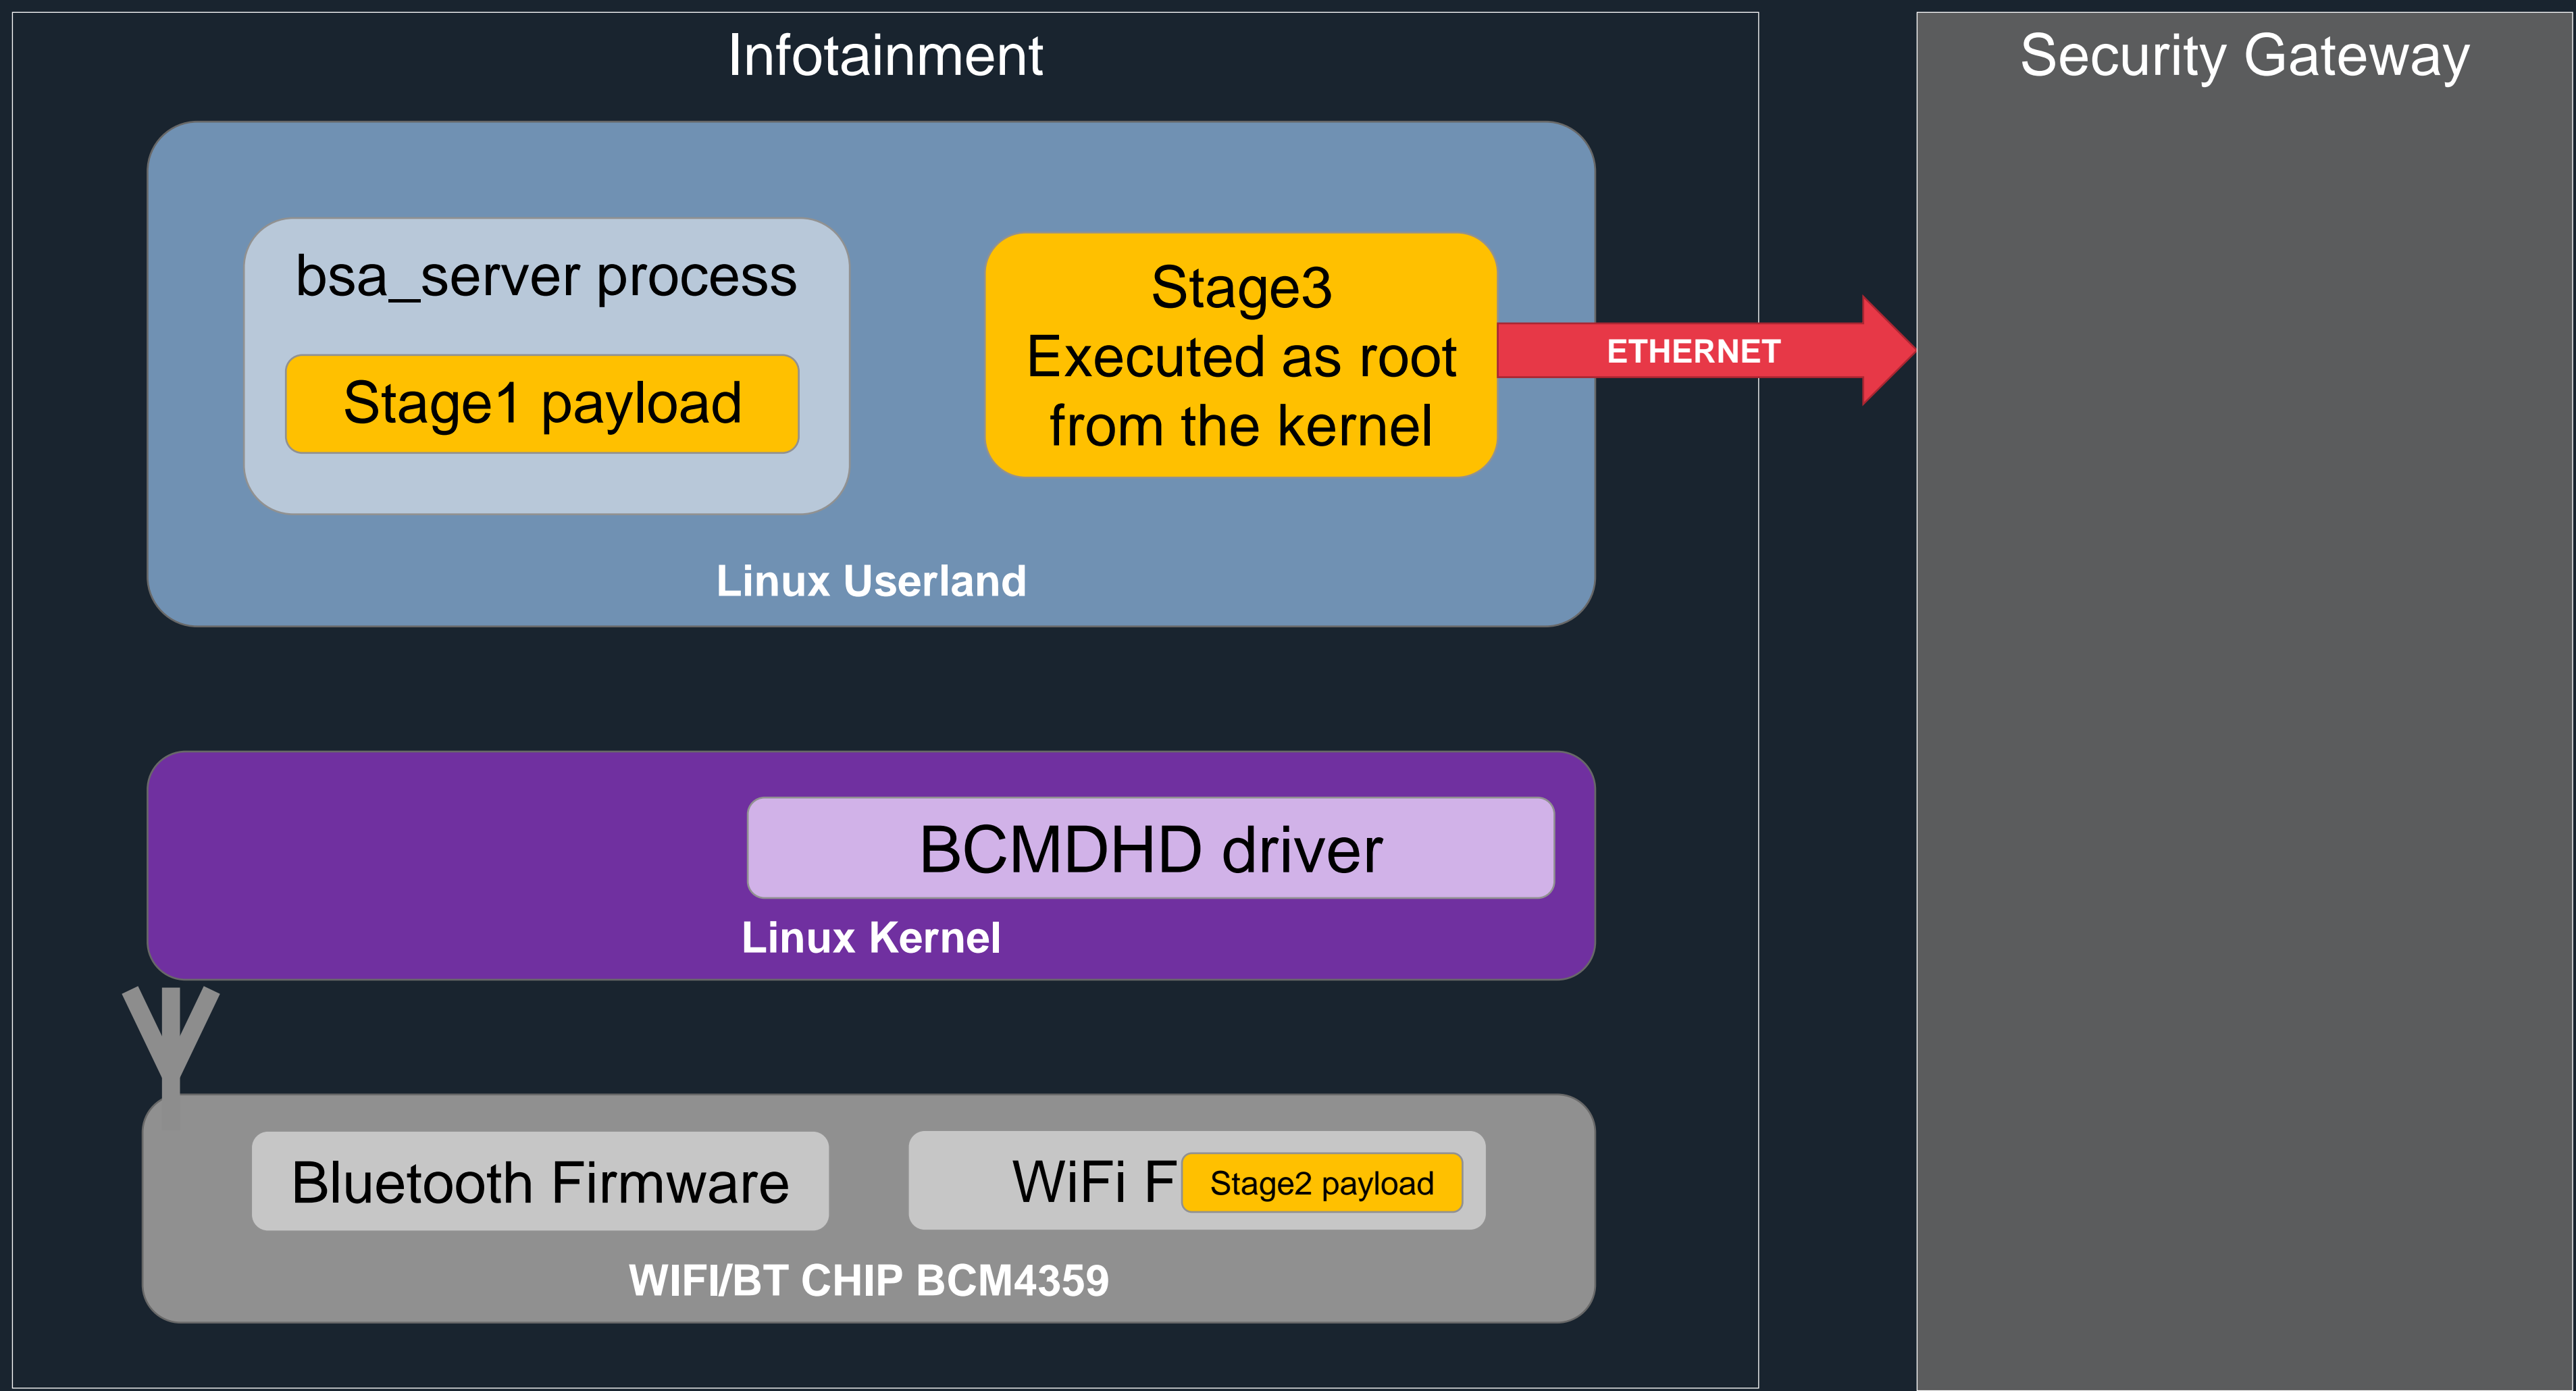
# LPE

root code execution

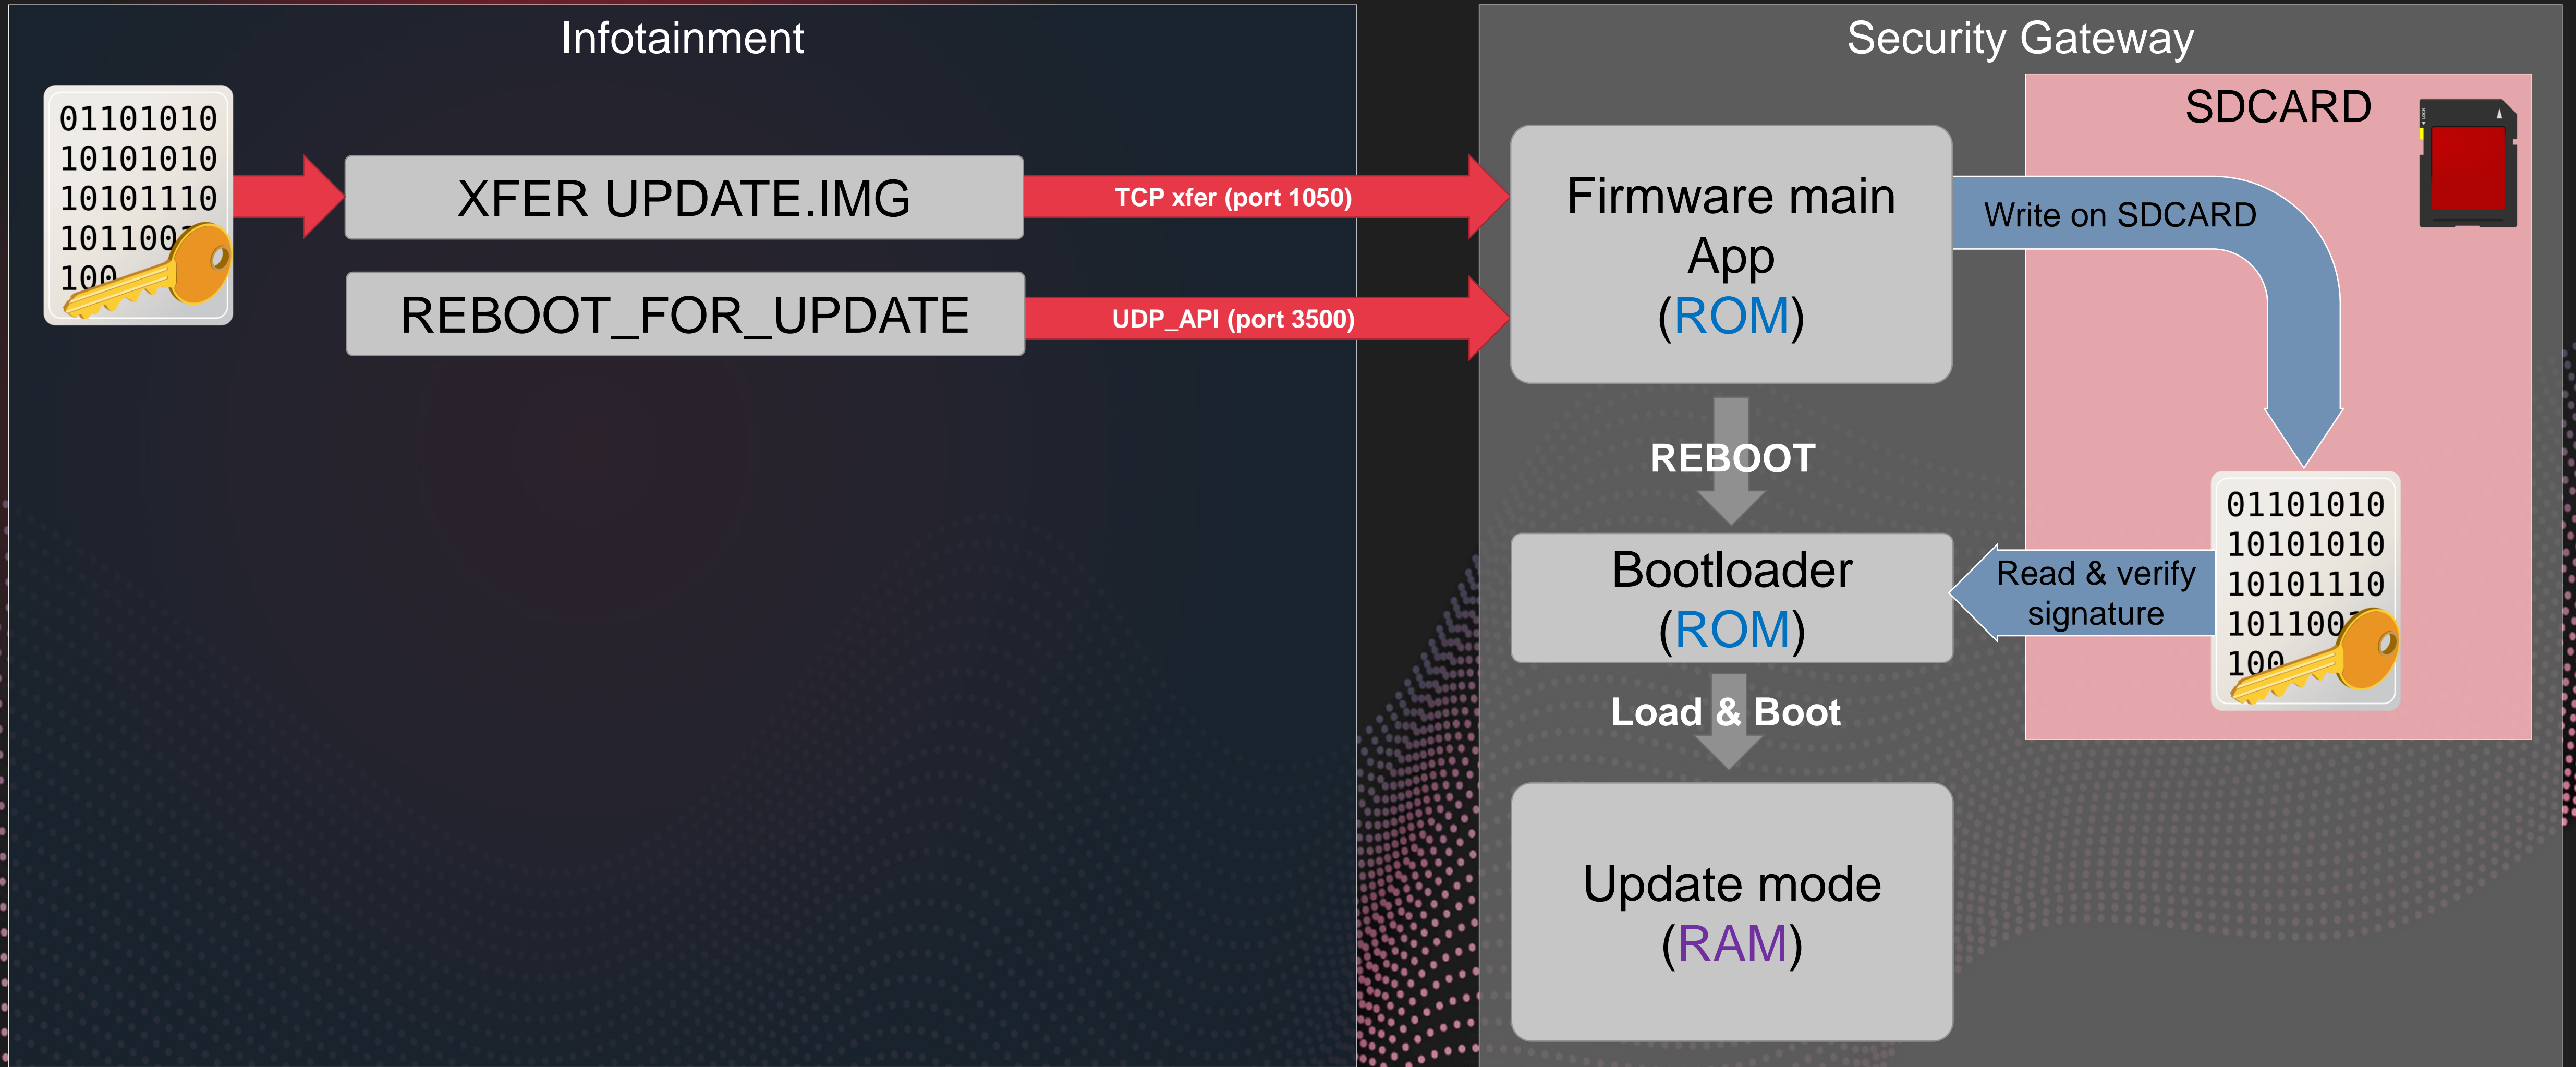
## Booting the update mode

- GTW uses fixed addresses (no ASLR, code is in the internal flash)
- Seems to be greatly audited, and safely developed
- Logic TOCTOU bug inside the update mode => **100% stable**

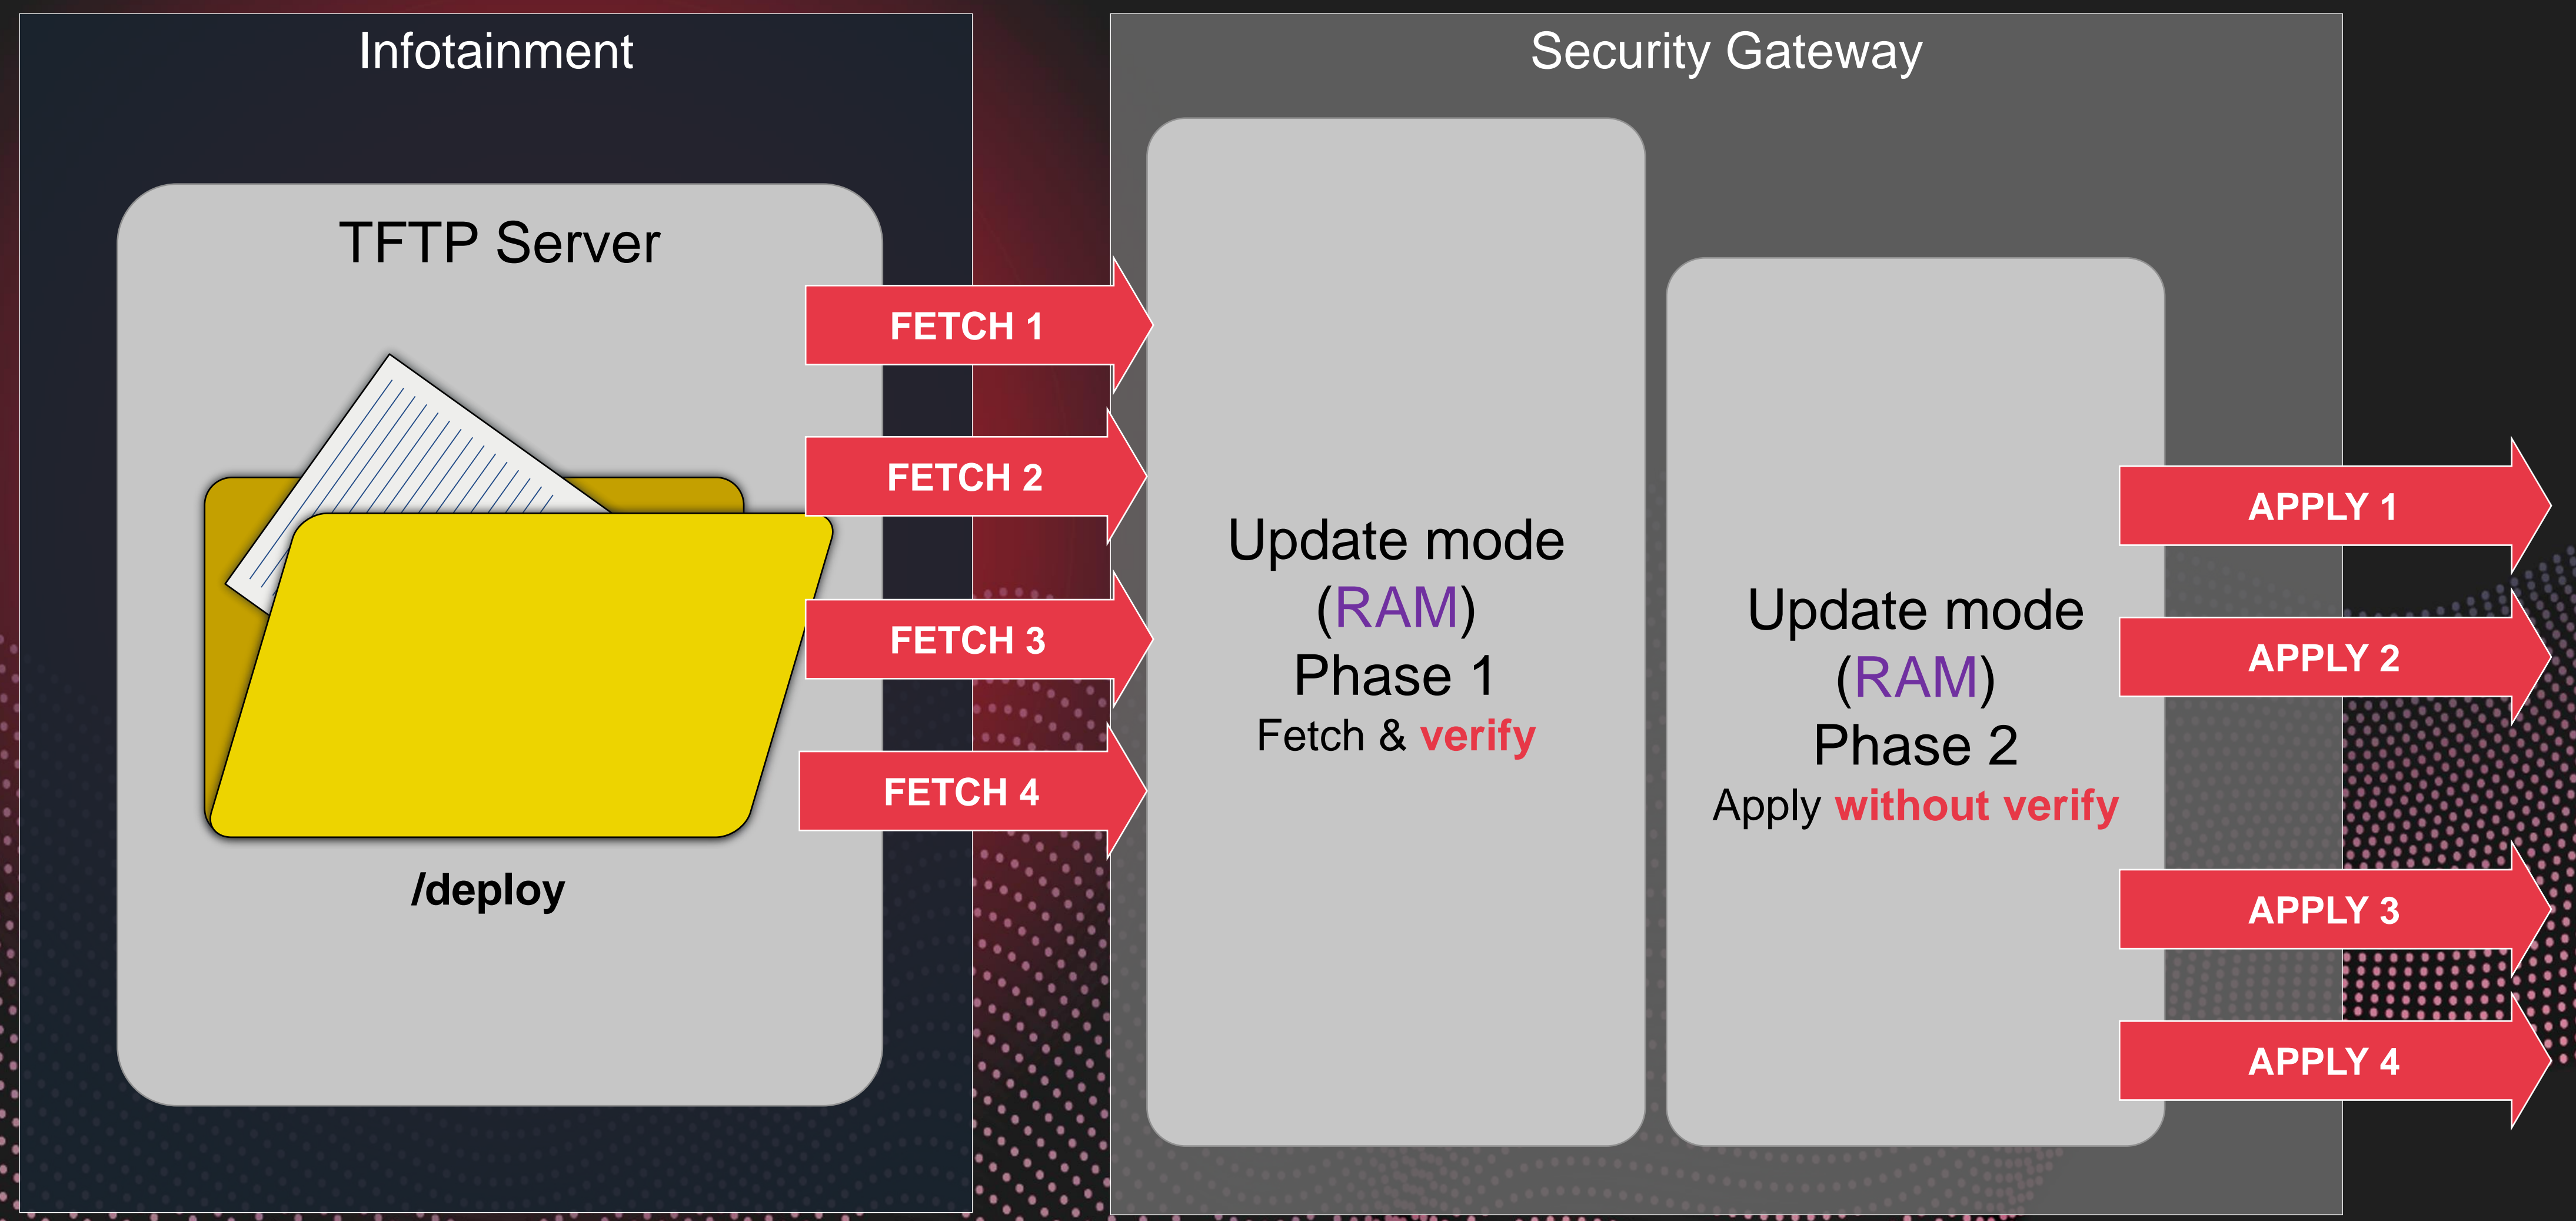
Update mode two phase mode

- Update mode can be forced to fetch two times the same ECU update
- The first time if the file has a good signature the **update is scheduled** to be applied, and the file is **saved on the SDCARD**
- The second fetch **overrides the file on the SDCARD**, if the signature is invalid the first one is still scheduled, and the bad temporary file is not removed
- When applying updates, the signature is not re-checked, so the **badly signed file is applied**
- This bypasses the signature check, and allows an attacker to apply **arbitrary updates**, and can be used to gain code execution on the security gateway
