# Unlocking the Drive

*Exploiting Tesla Model 3*

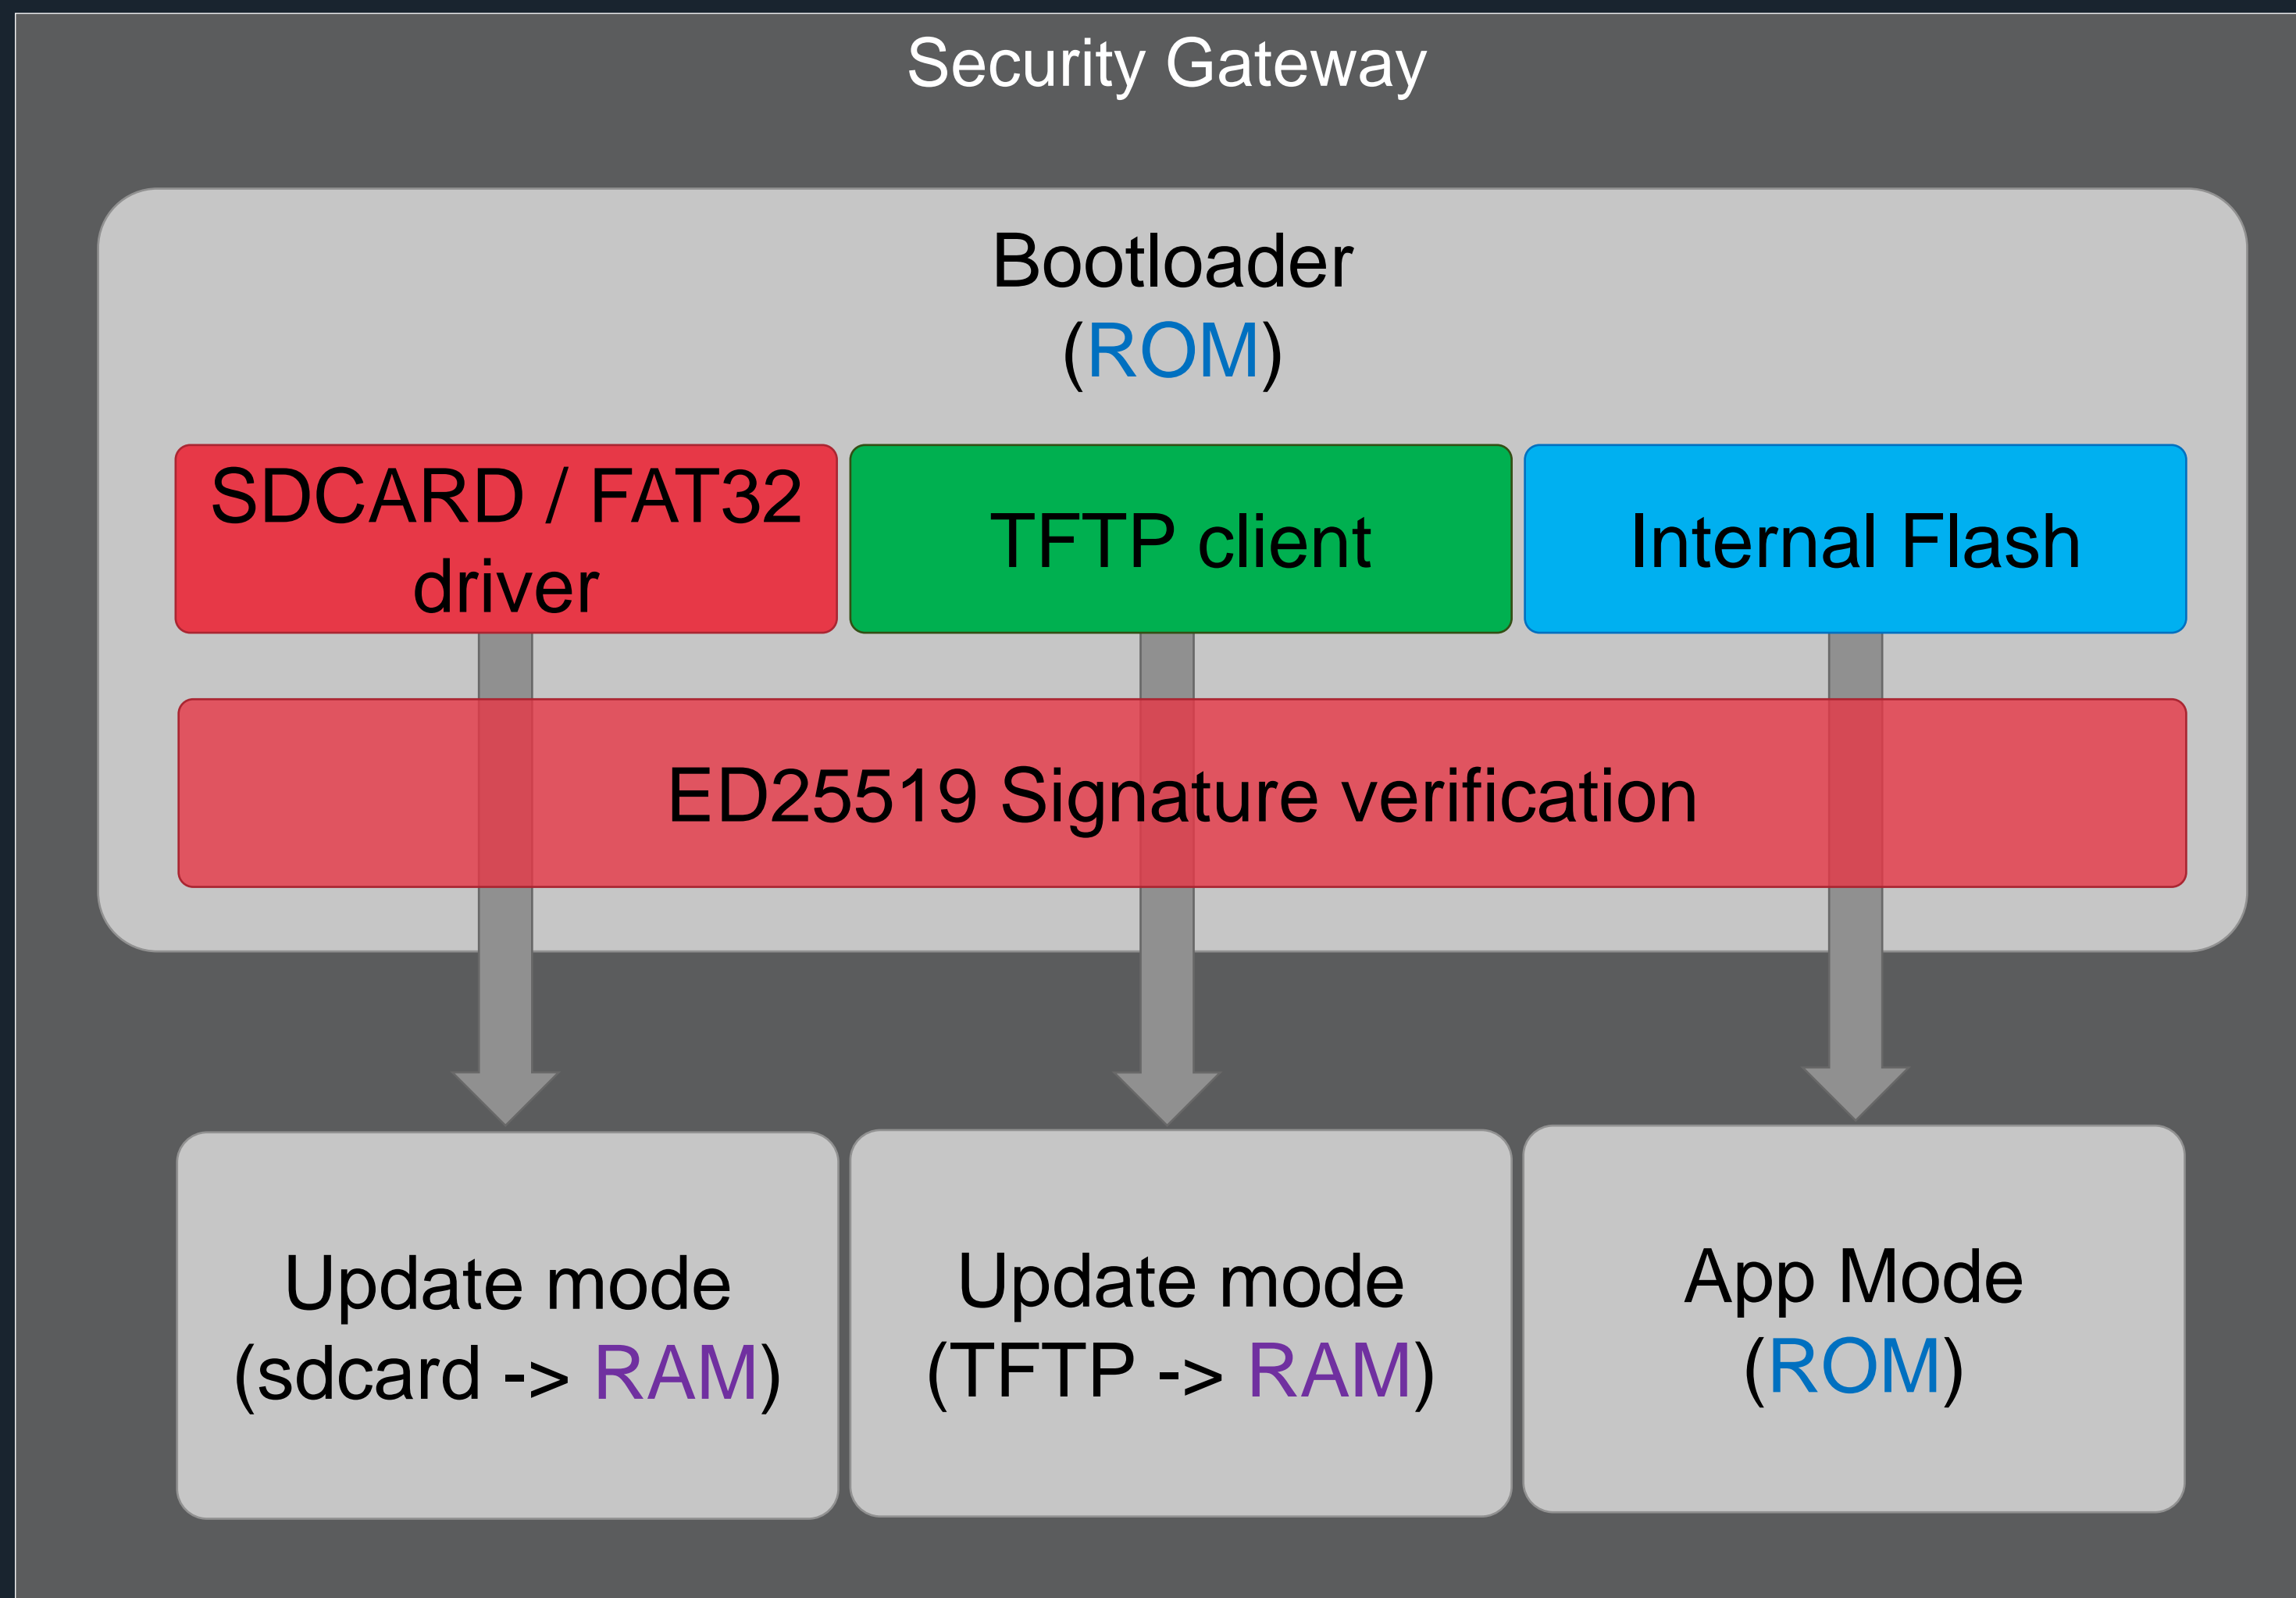
Secure boot

- Bootloader verifies next stages
- Hardware (NXP chip) **doesn't provide secure boot**, bootloader in the internal flash is never verified
- Gateway update mode allows to update its own firmware, including the bootloader
- Signature bypass in update mode => **code exec in bootloader**
