# Unlocking the Drive

## *Exploiting Tesla Model 3*

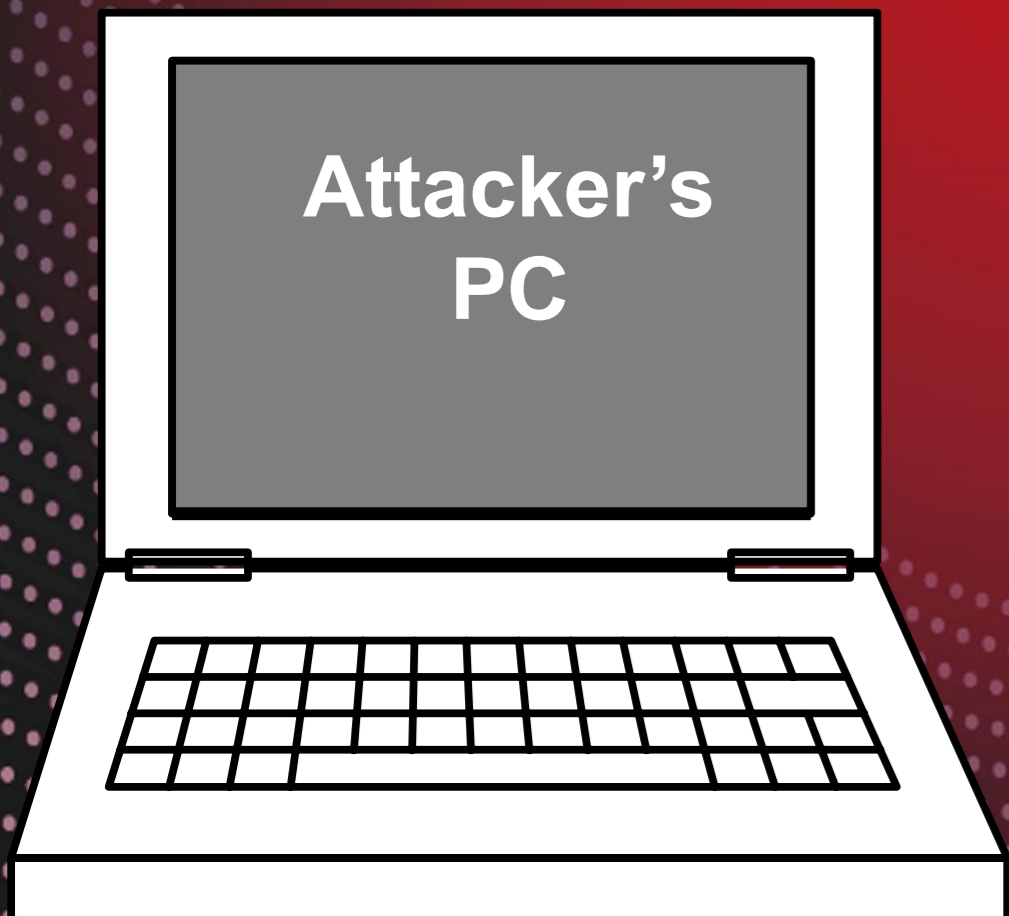
# Exploit chain

Chaining **three exploits** for a remote-to-CAN fullchain

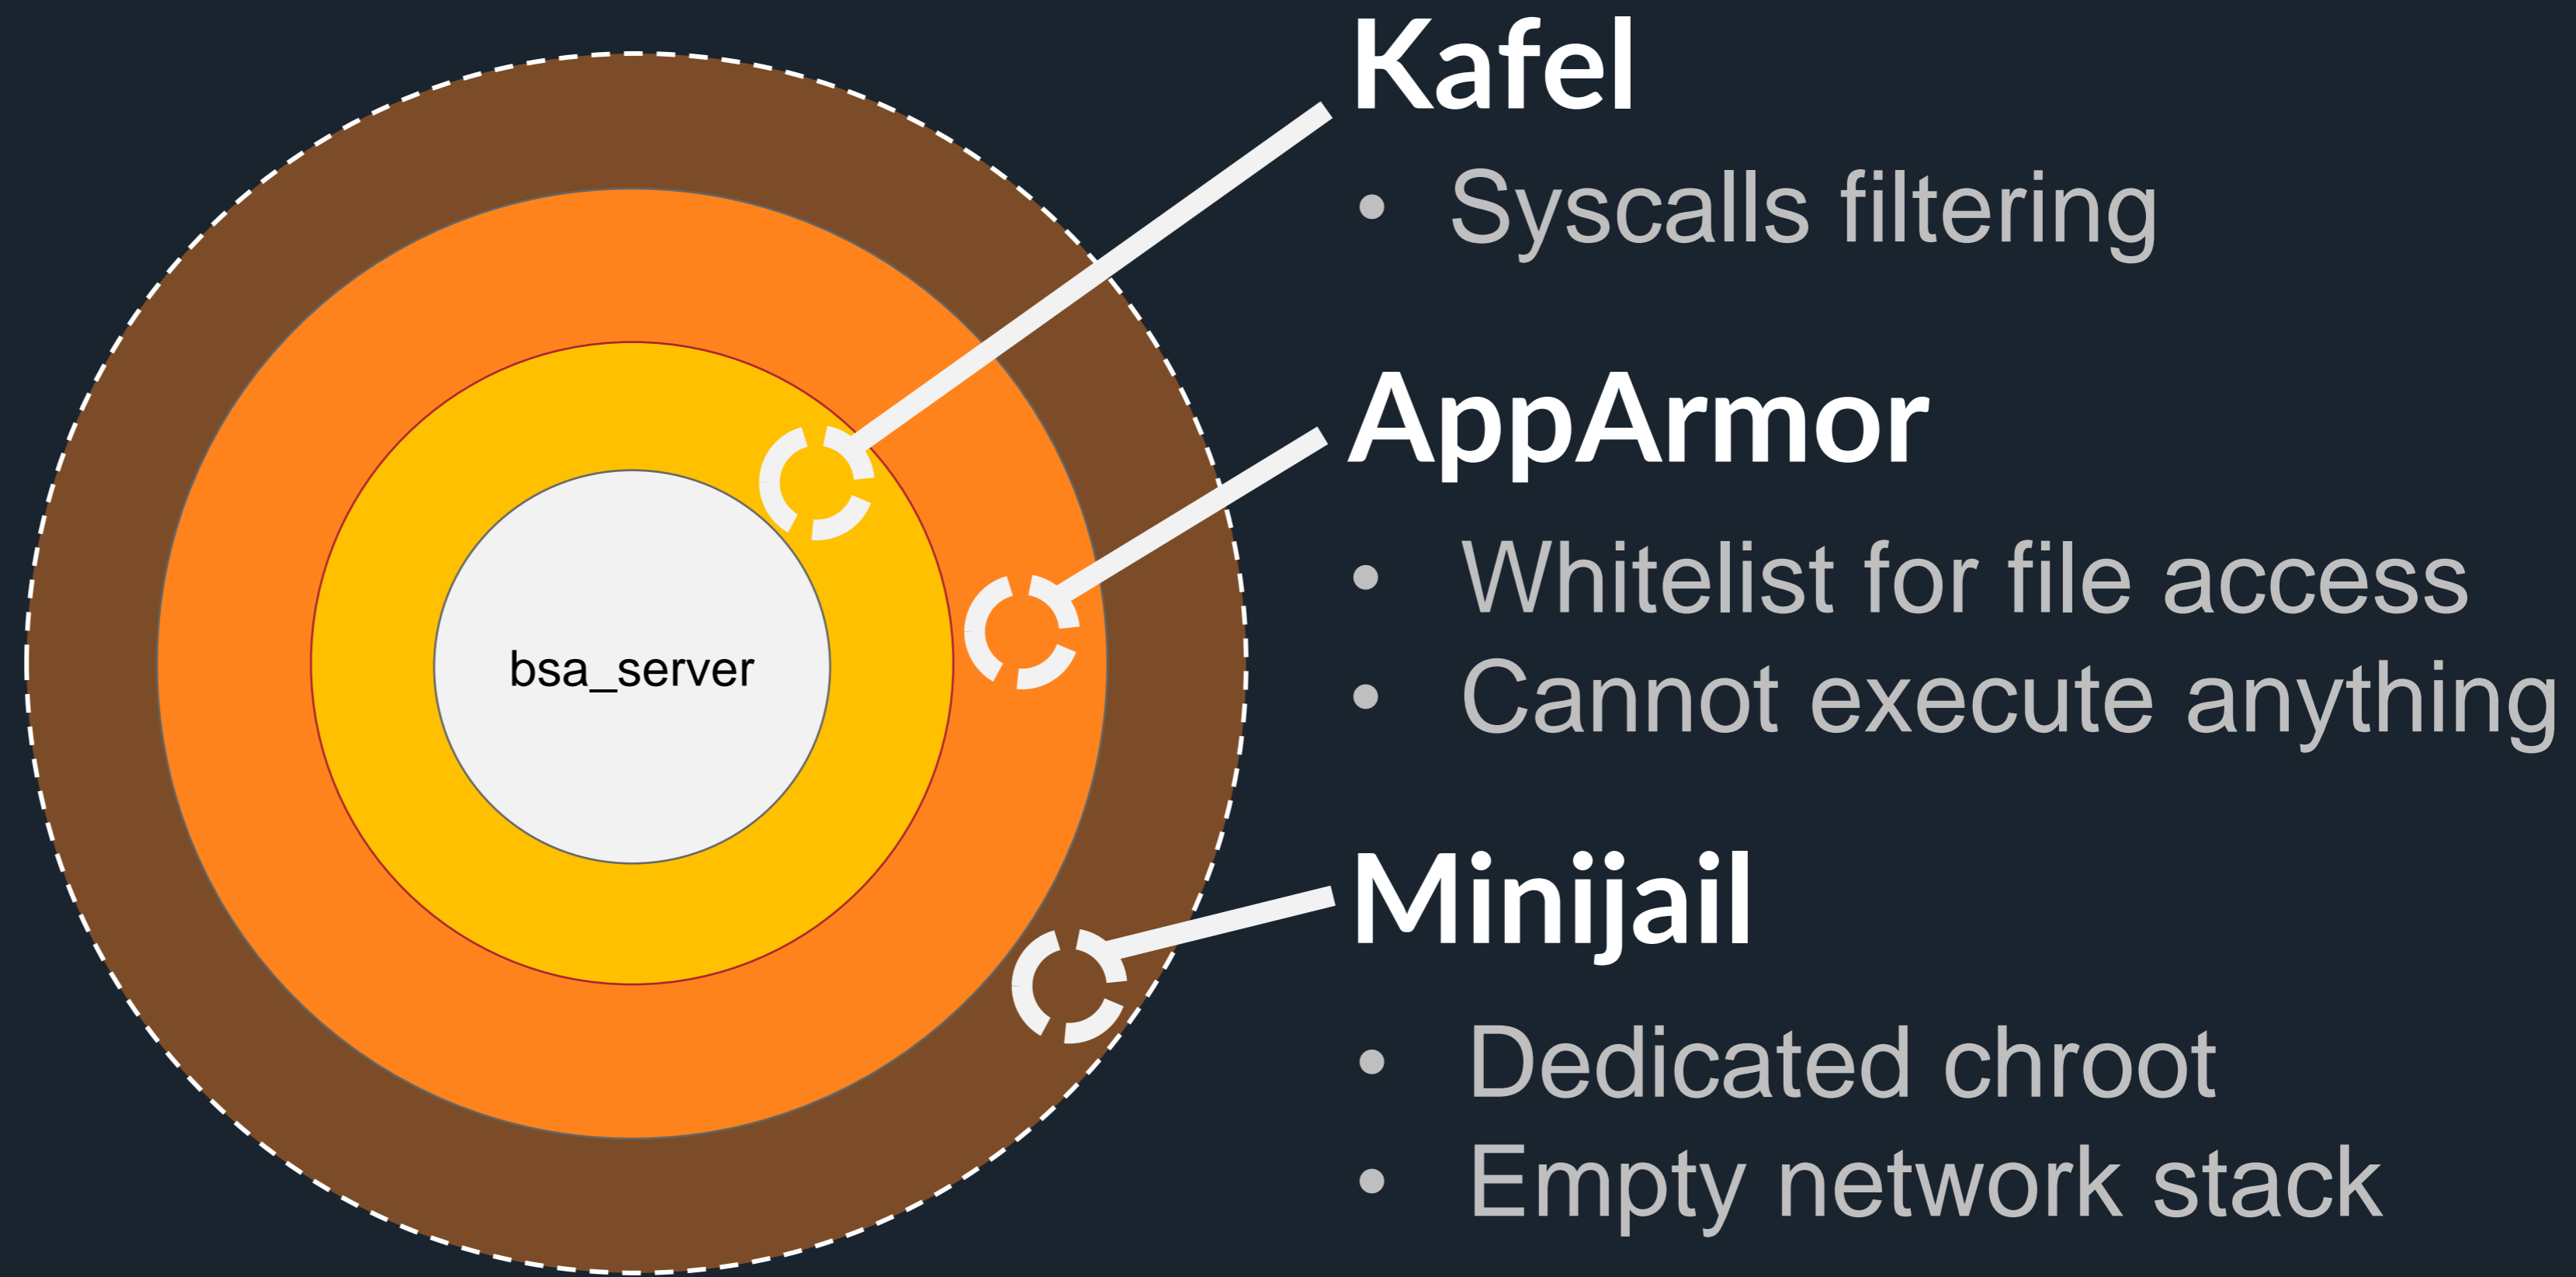
# The end ?

What can we do with this code execution ?

- Dedicated UID
- No useful capability
- No network
- All **sandboxes activated**
- But two legitimate APIs
  - TTY communication
  - One UNIX socket to communicate with btd
- Limited attack surface

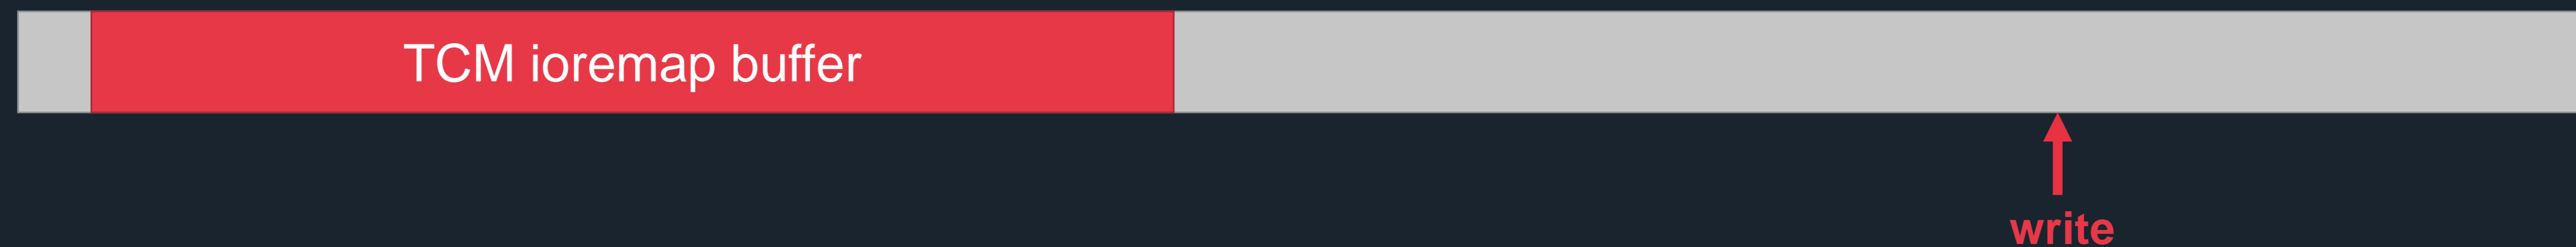
# LPE

Out-of-bound write in bcmdhd

- `d2h_r_idx_ptr` is used as an offset to write inside a ioremap region (TCM)
- The offset is not checked to be in the TCM region!
- ioremap places addresses in the vmalloc region
- **Stage2** can write out of bound after the ioremap TCM region by setting `d2h_r_idx_ptr` to a value bigger than the TCM size
- Need to find something to write on!
